# Memorandum

**Subject:** Data Evaluation Report, 2021 Residential Soil Sampling

**Project Name:** Old American Zinc Plant Superfund Site, Fairmont City, St. Clair County and Madison County, Illinois  
Task Order No. 68HE0521F0068/Contract No. 68HE0318D0004

**DCN:** DES-R5-21F0068-02005

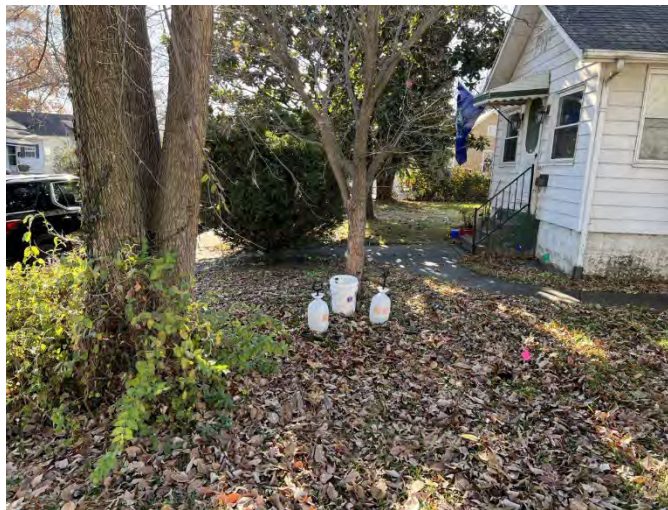
**Photograph 1: Temporary decontamination set up.**

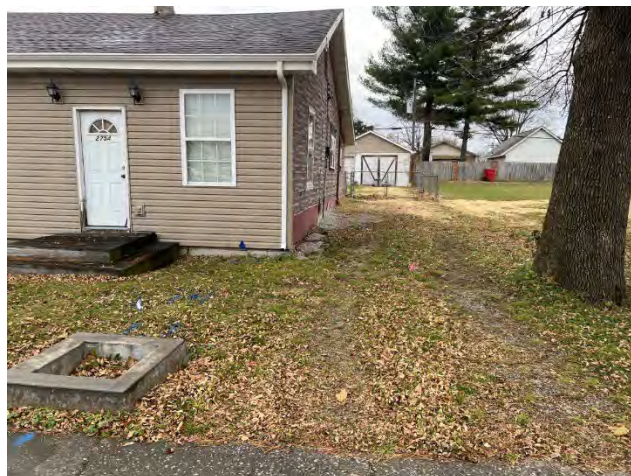
**Photograph 2: Yard showing utility markings.**

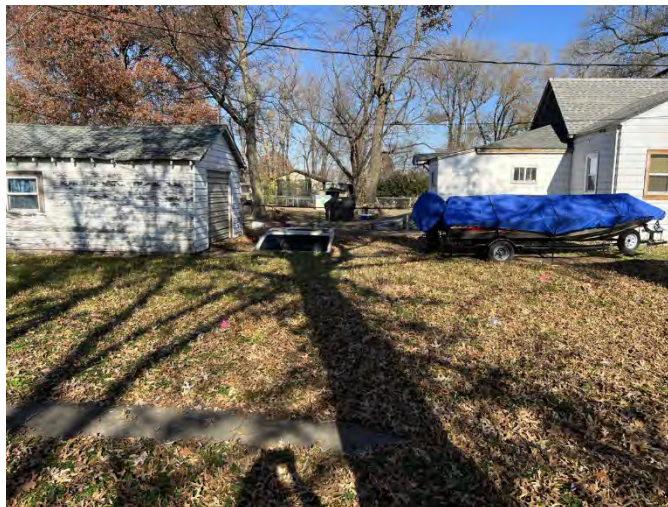
**Photograph 3: Yard showing sampling flags.**

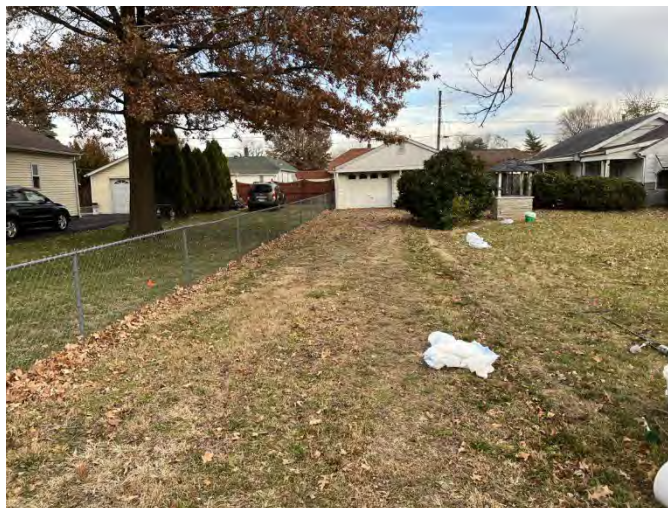
**Photograph 4: Sampling set up.**

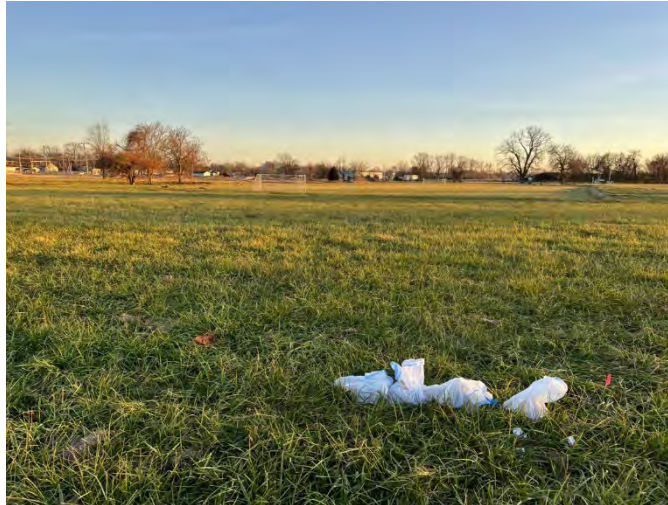
**Photograph 5: Sampling set up.**

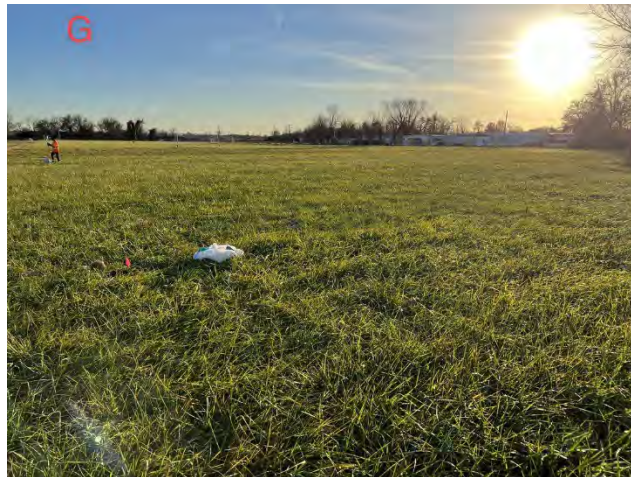
**Photograph 6: Sampling set up at yard section G of a property.**

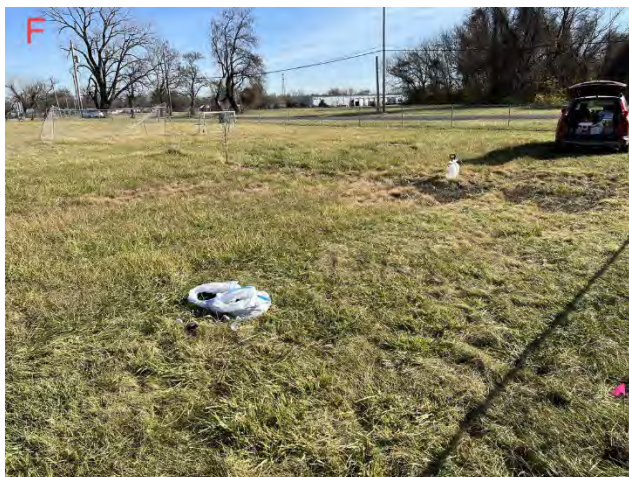
**Photograph 7: Sampling set up at yard section F of a property.**

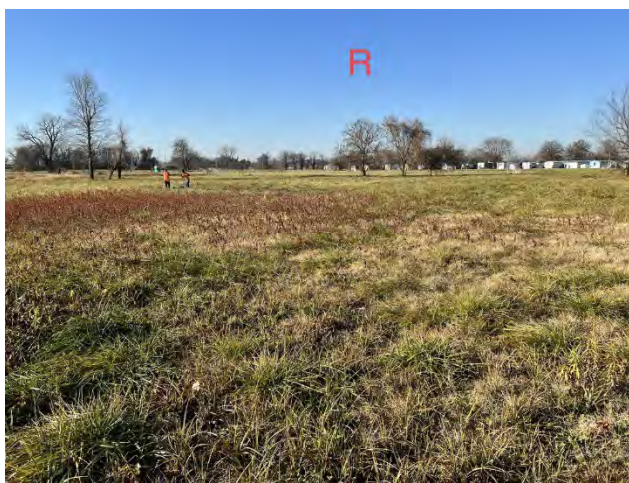
**Photograph 8: Sampling set up at yard section R of a property.**

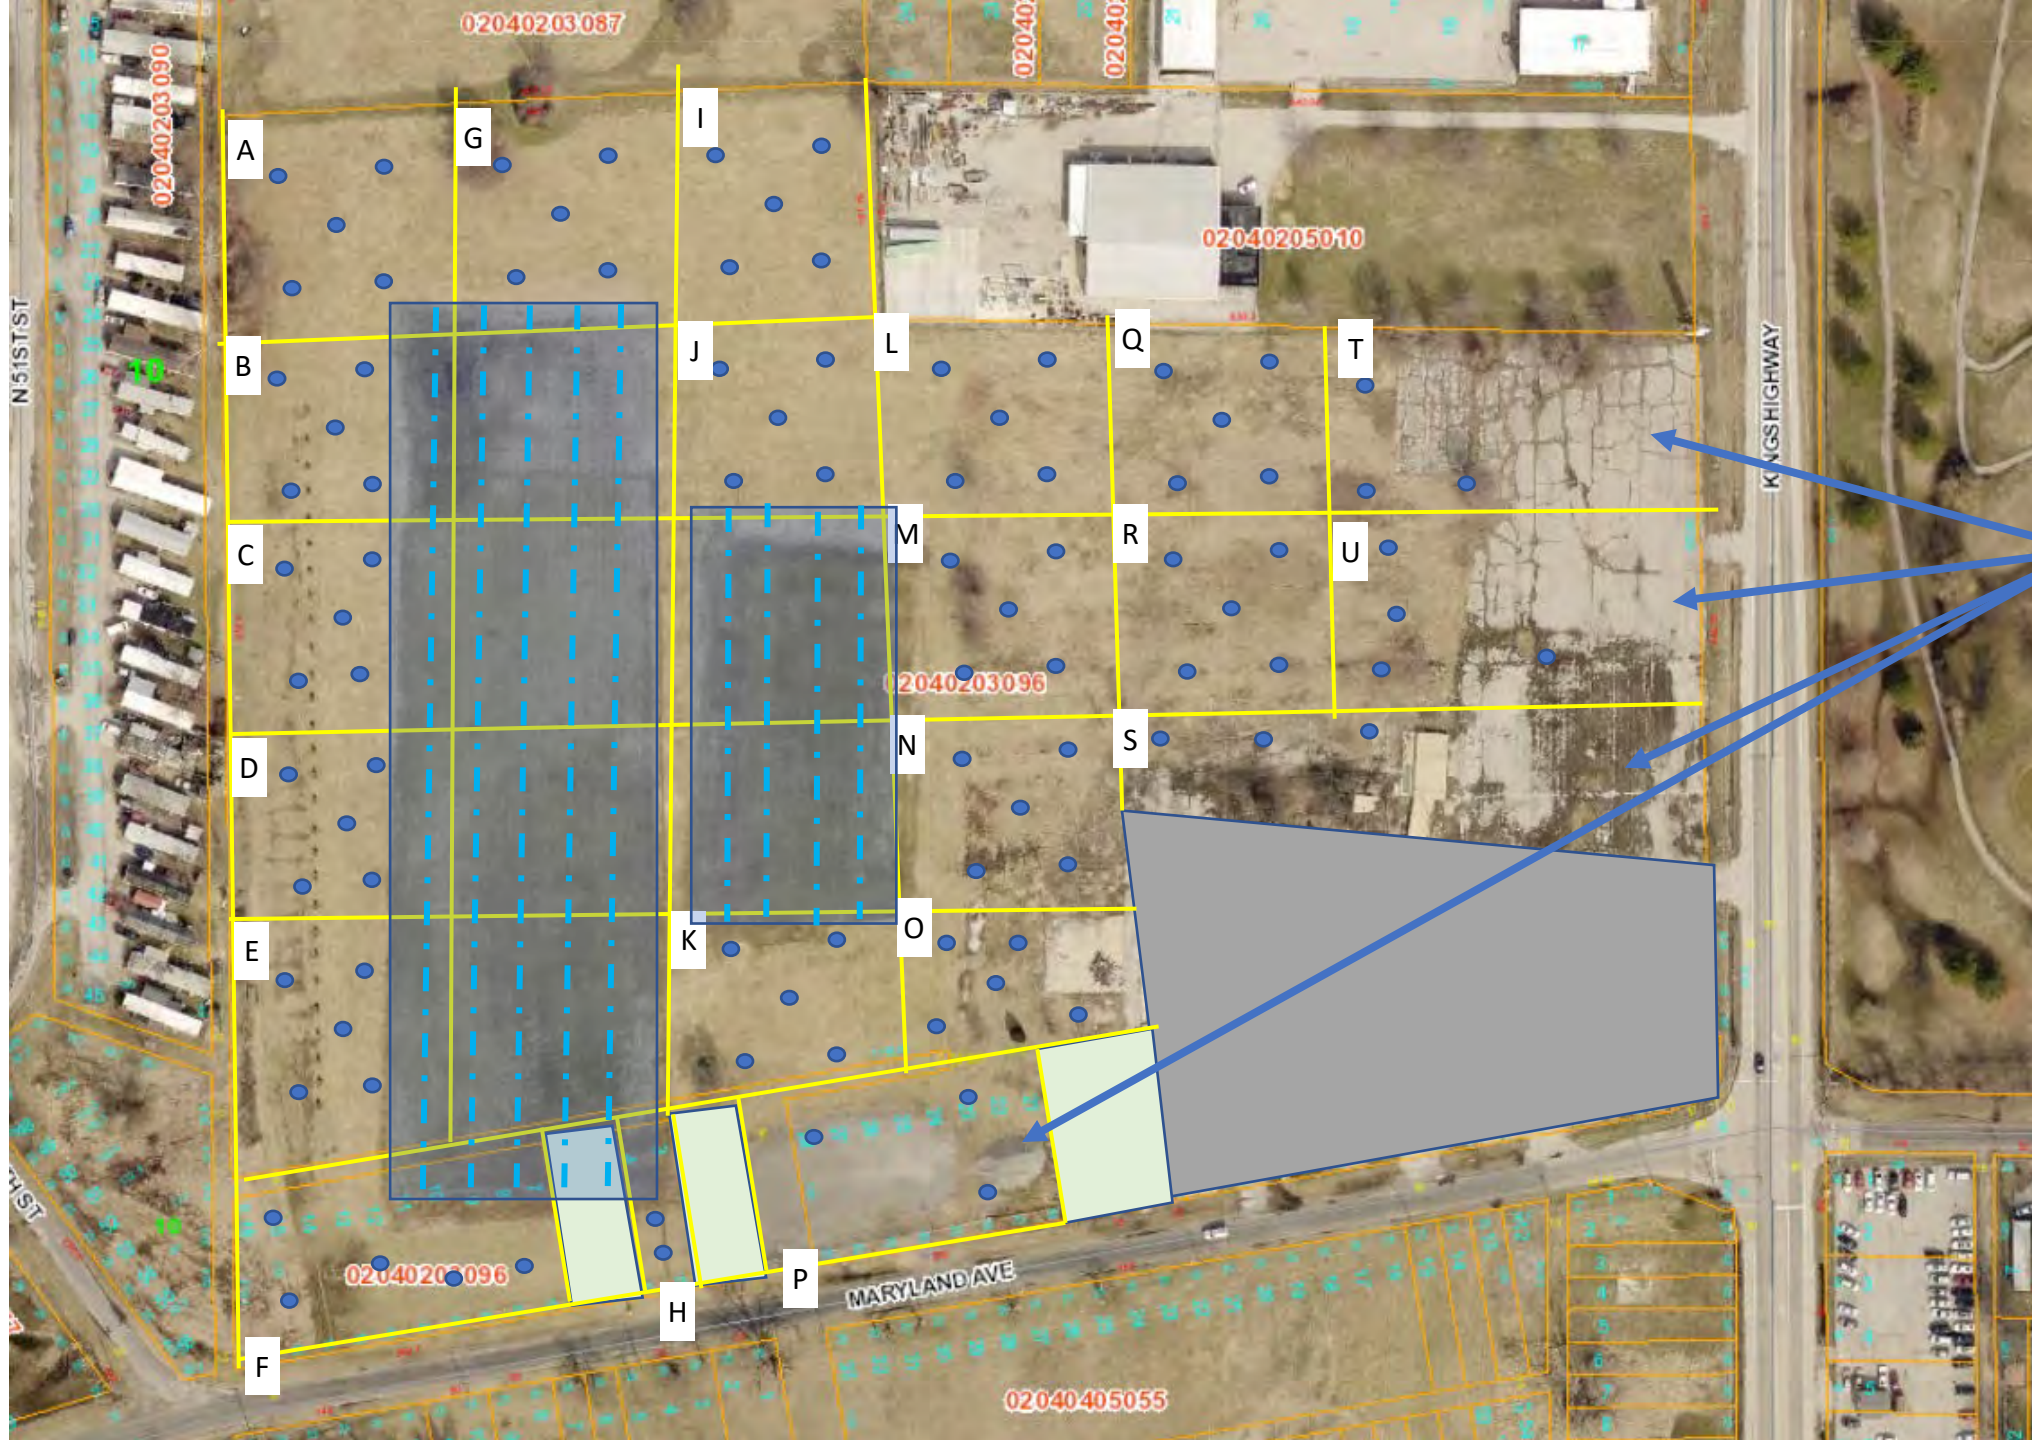
Fewer aliquots  
collected in these  
areas due to concrete

Irrigate lines run N-S  
within constructed  
soccer fields (appears  
to be new fill and sod  
on soccer fields).  
Irrigation lines not  
traceable using GPR.
